DAMAGE MECHANISMS AND FAILURE OF 3-D CARBON-CARBON COMPOSITES.(U)

# DAMAGE MECHANISMS AND FAILURE OF 3-D CARBON-CARBON COMPOSITES

Interim Report for Period August 1977 - August 1978  
Contract N00014-77-C-0510

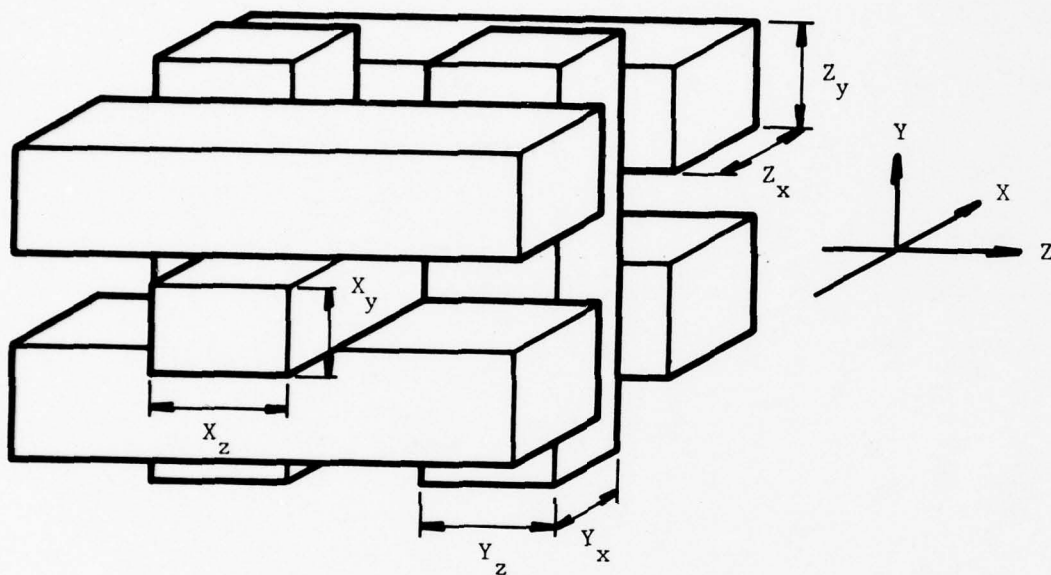
FIGURE 1. BASIC GEOMETRY OF 3-D CARBON-CARBON MATERIAL SYSTEM WITH RECTANGULAR YARN BUNDLES.

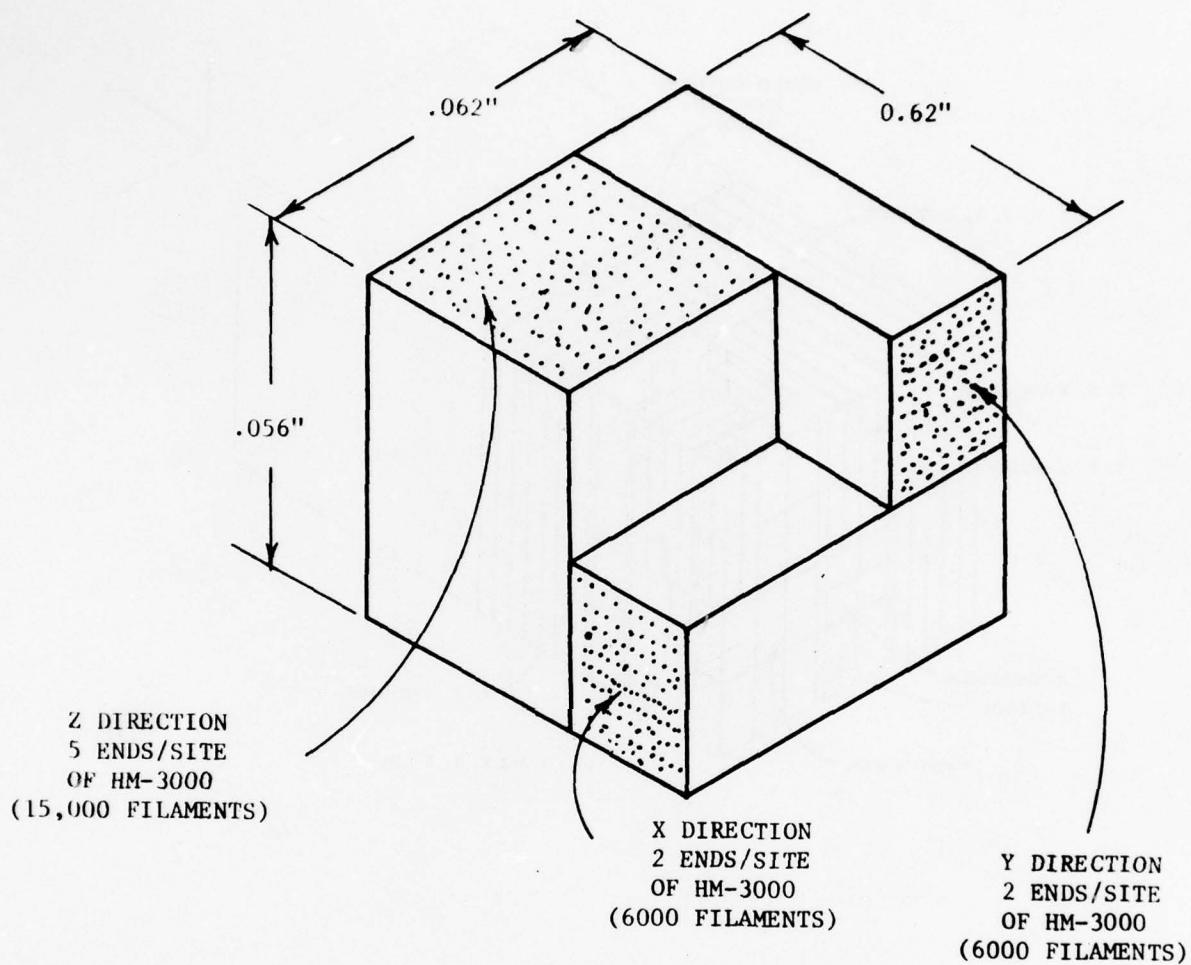
FIGURE 2. SCHEMATIC DRAWING OF UNIT CELL STRUCTURE FOR 2,2,3 CARBON-CARBON MATERIAL. DIMENSIONS FURNISHED BY SUPPLIER (FIBER MATERIAL, INC.).

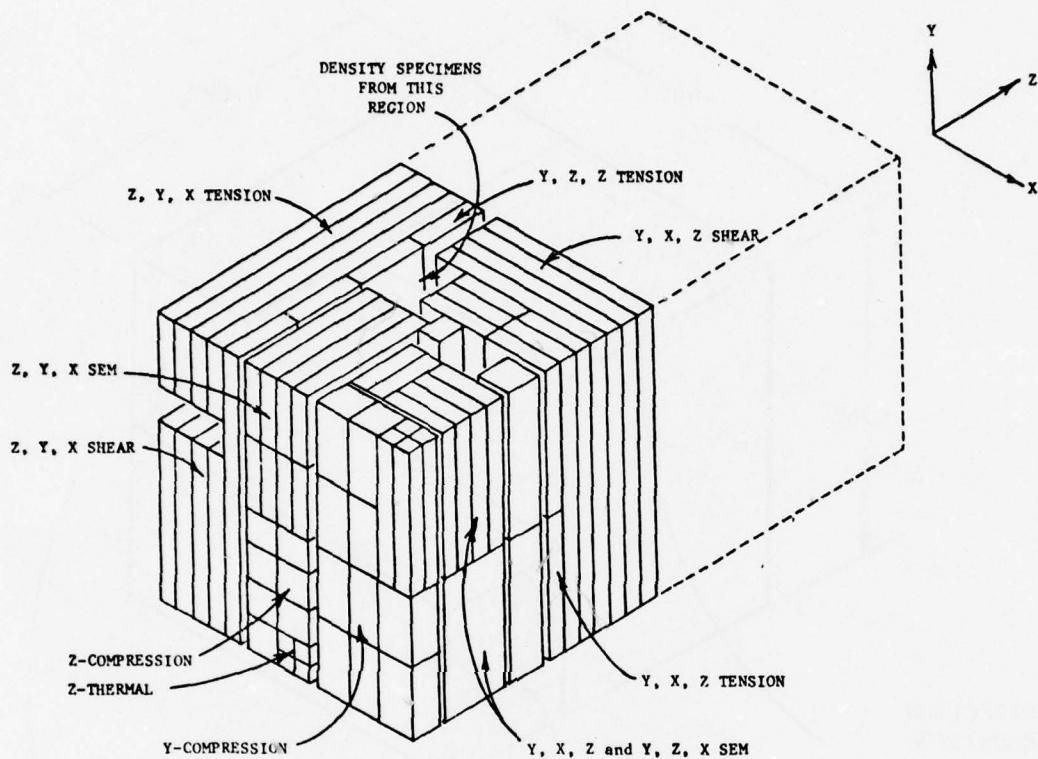
FIGURE 3. CUTTING SCHEME, FOR BILLET NO. 2696, WHICH PRODUCED MECHANICAL TEST SPECIMENS AS WELL AS DENSITY AND THERMAL EXPANSION SPECIMENS.

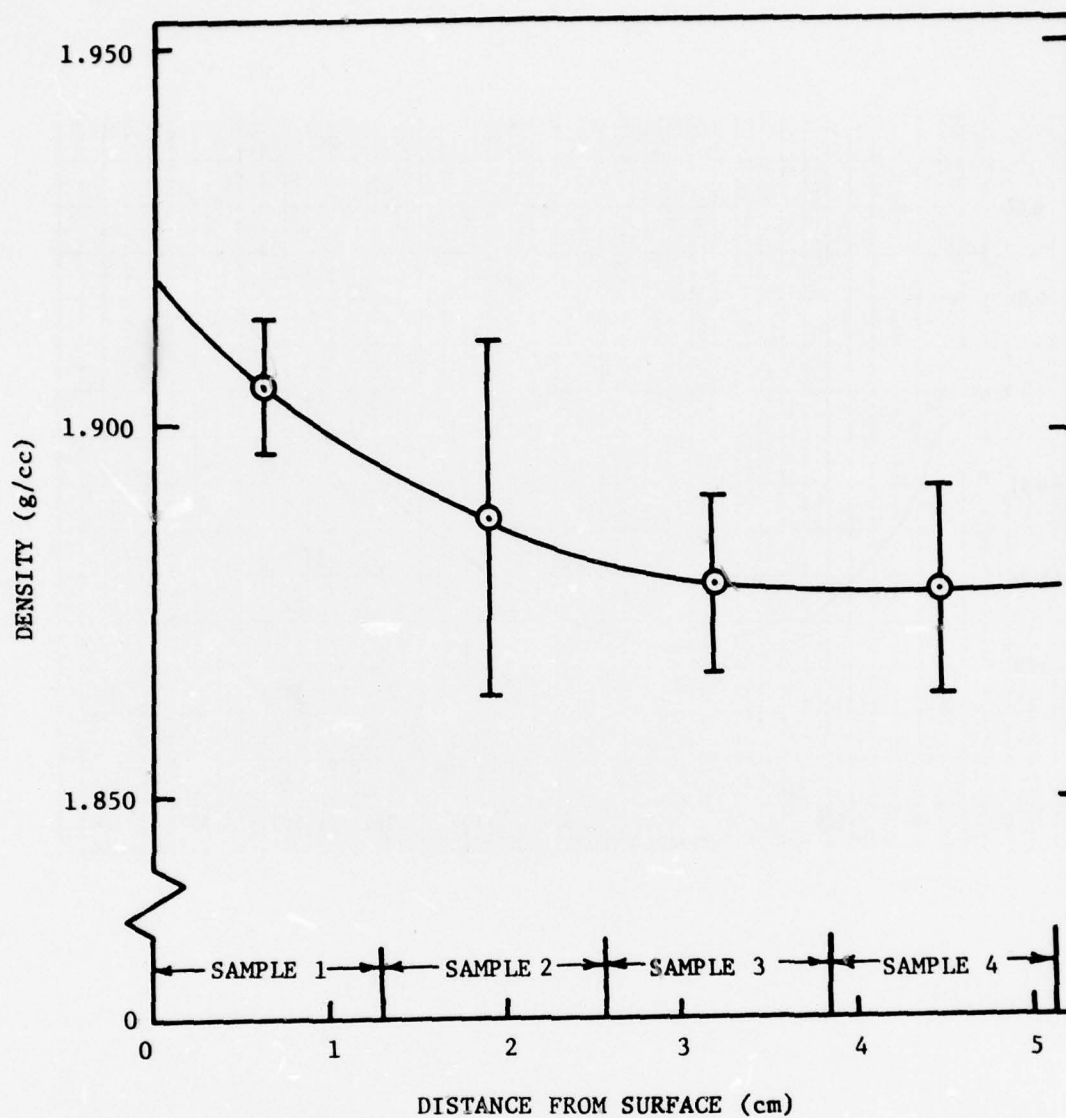
FIGURE 4. DENSITY PROFILE OF AS-RECEIVED CARBON-CARBON BILLET. DENSITY SPECIMENS RANGED FROM AN OUTSIDE SURFACE TO THE CENTER OF THE BILLET.

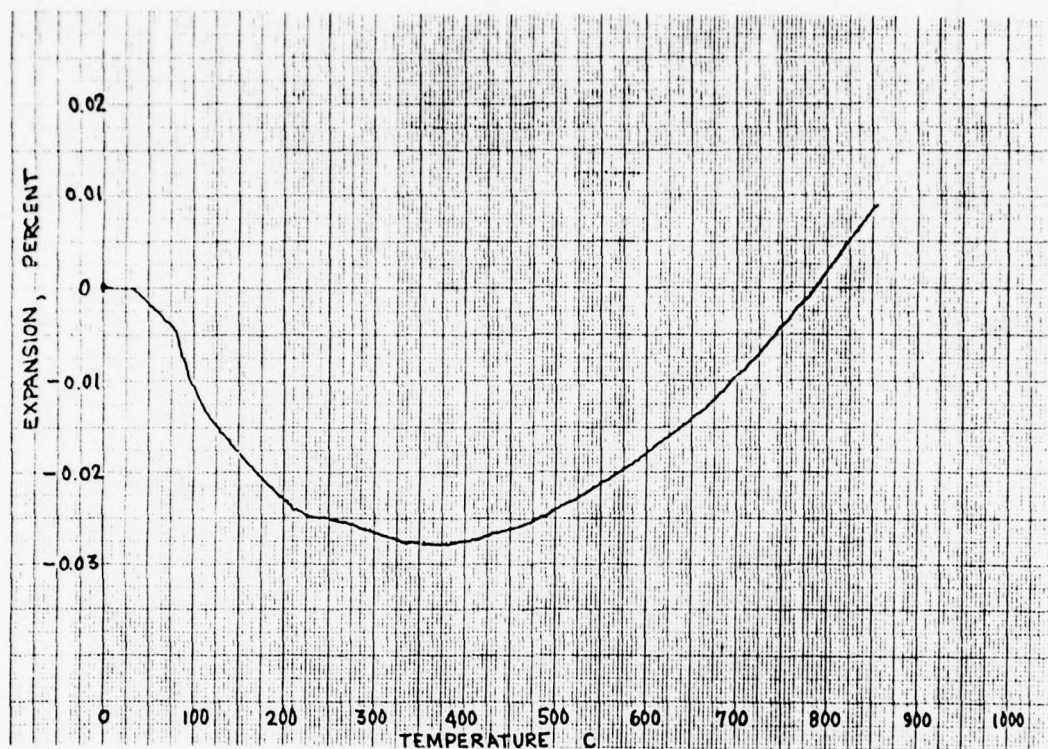
FIGURE 5. TYPICAL THERMAL EXPANSION CURVE FOR THE LOWER TEMPERATURE RANGES AS RECORDED BY A QUARTZ-TUBE DILATOMETER. SPECIMEN NO. TH-1.

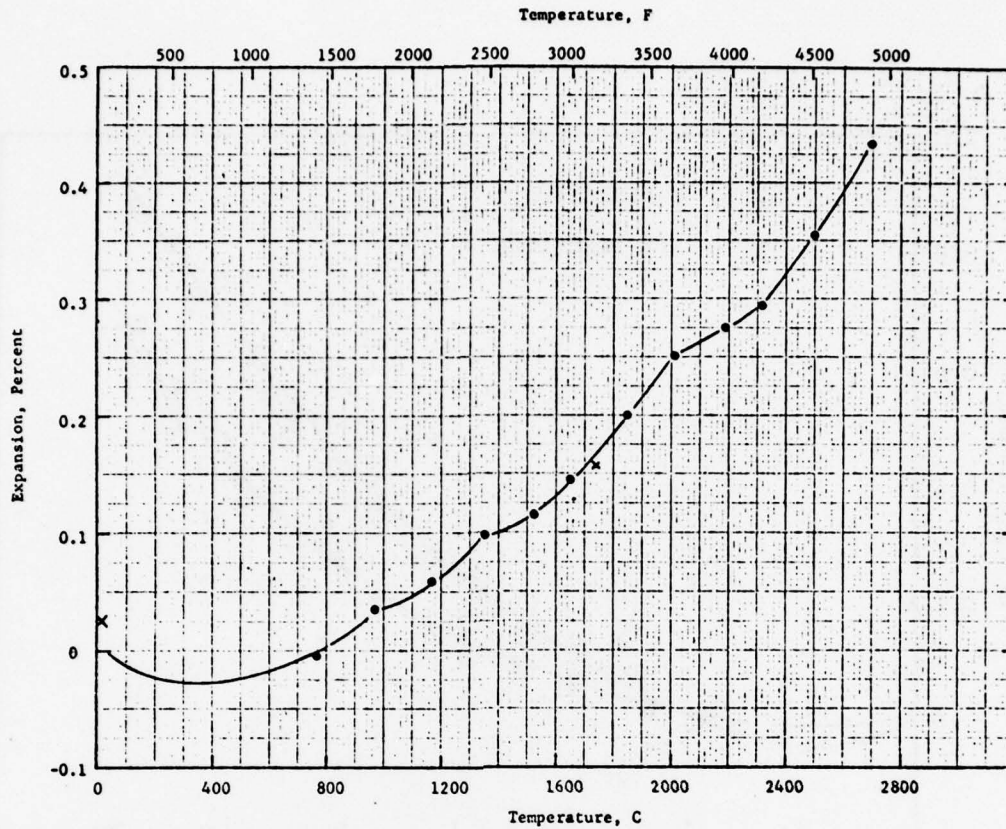
FIGURE 6. TYPICAL THERMAL EXPANSION PROFILE FOR HIGHER TEMPERATURE RANGES AS OBSERVED IN AN OPTICAL DILATOMETER. SPECIMEN TH-1.

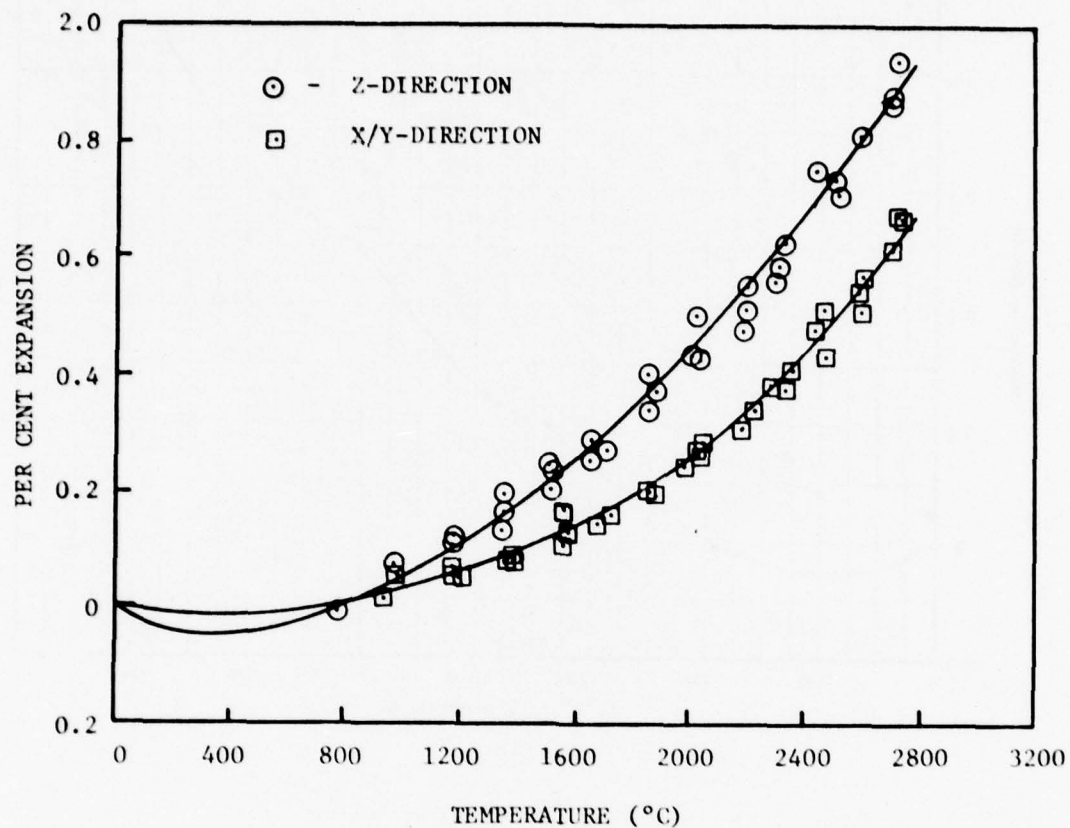
FIGURE 7. COMPLETE THERMAL EXPANSION CURVES FOR BOTH THE Z- AND THE Y-DIRECTIONS, FROM 20°C TO 2700°C. THE CURVE SHOWN IS A VISUAL FIT.

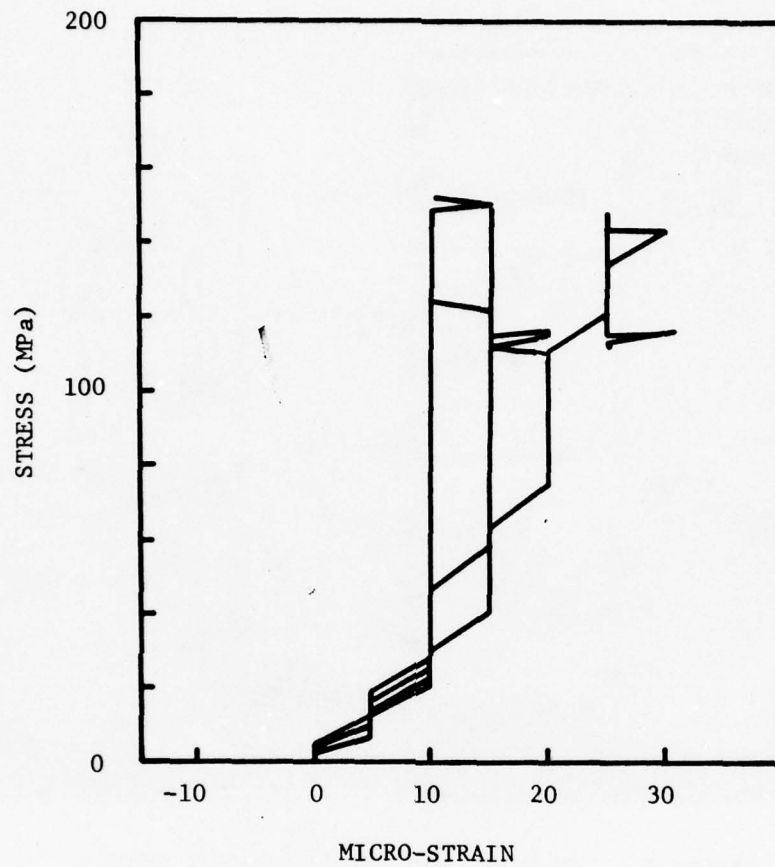
FIGURE 9. TYPICAL STRESS-STRAIN RELATIONS AS MEASURED BY TRANSVERSE STRAIN GAGES ON ALL FOUR SIDES OF A COMPRESSION SPECIMEN. SPECIMEN C-1 (Z-DIRECTION).

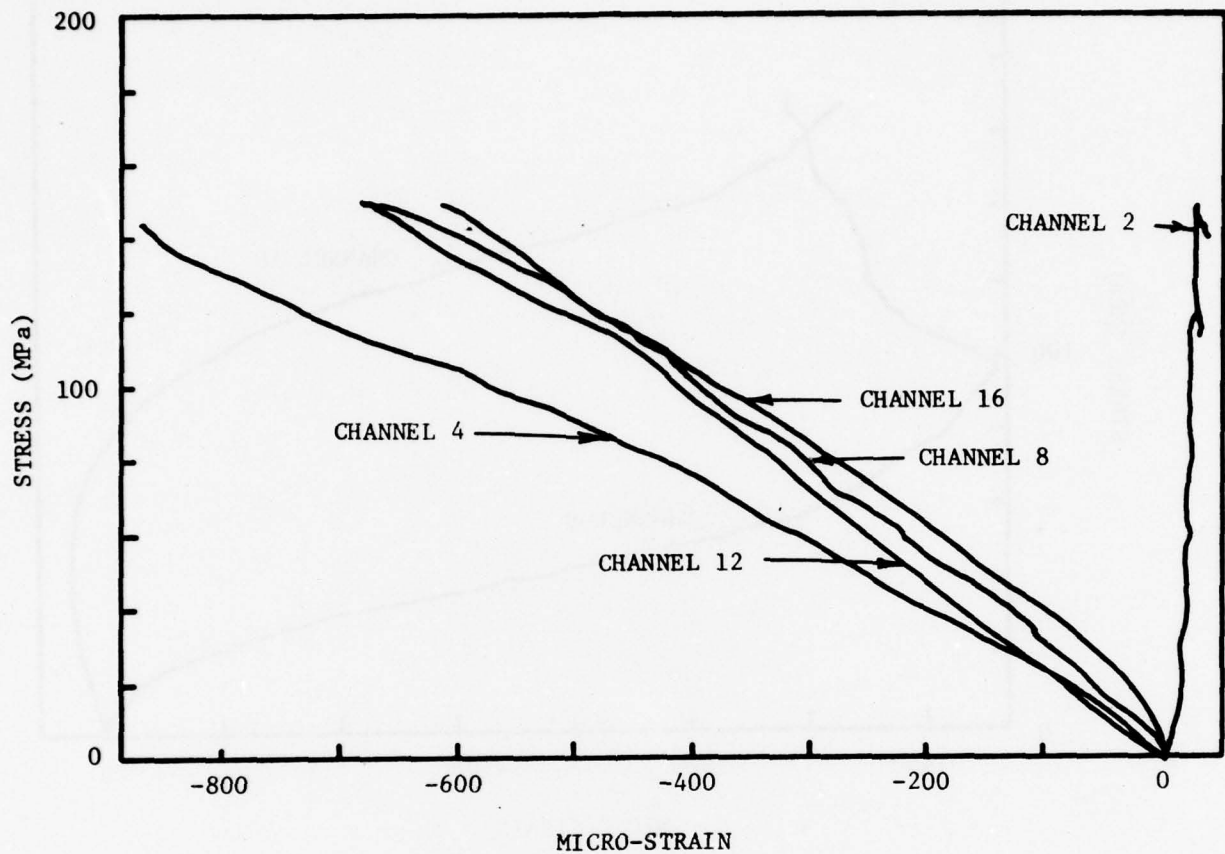
FIGURE 10. TYPICAL STRESS-STRAIN RELATIONS AS MEASURED BY LONGITUDINAL STRAIN GAGES ON ALL FOUR SIDES OF A COMPRESSION SPECIMEN. A TRANSVERSE CHANNEL IS SHOWN FOR COMPARISON. SPECIMEN C-1 (Z-DIRECTION).

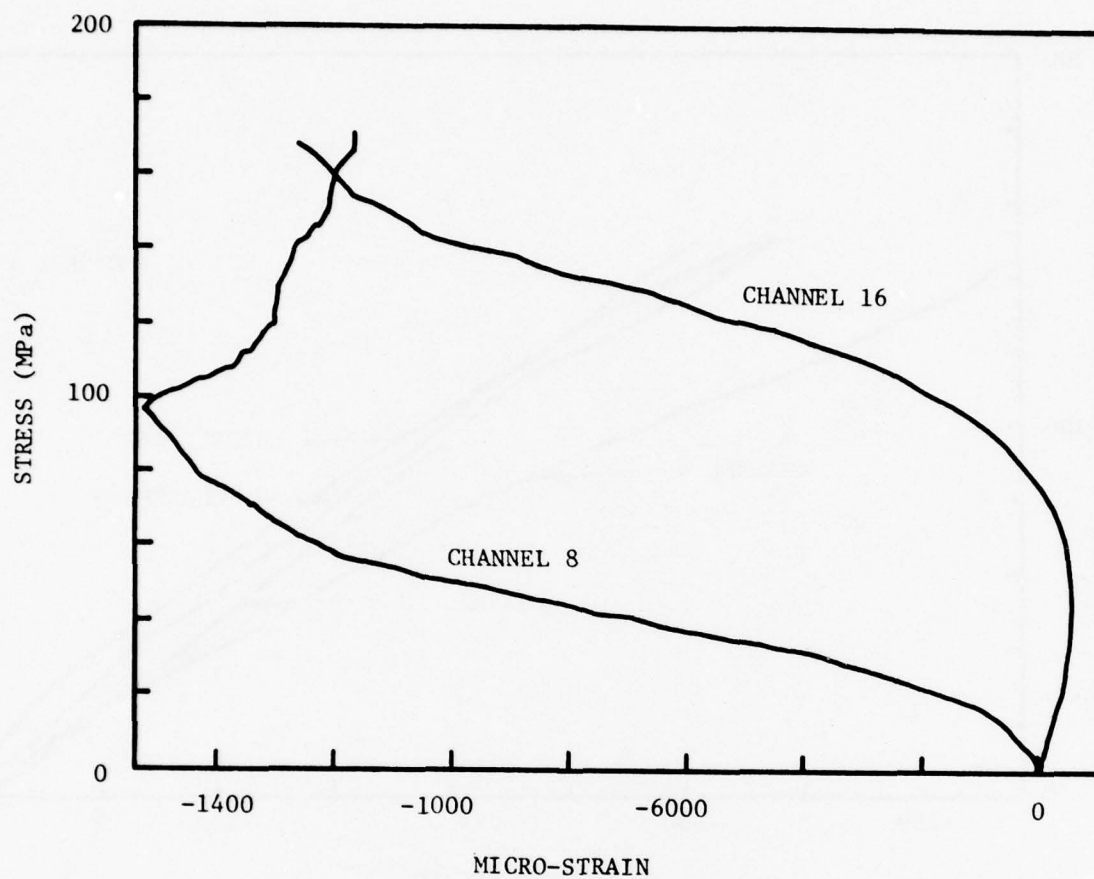
FIGURE 11. STRESS-STRAIN RELATIONS FOR TWO GAGES ON OPPOSITE SIDES OF A SPECIMEN WHICH EXHIBITED CONSIDERABLE BENDING DURING A COMPRESSION TEST. SPECIMEN C-3 (Z-DIRECTION).

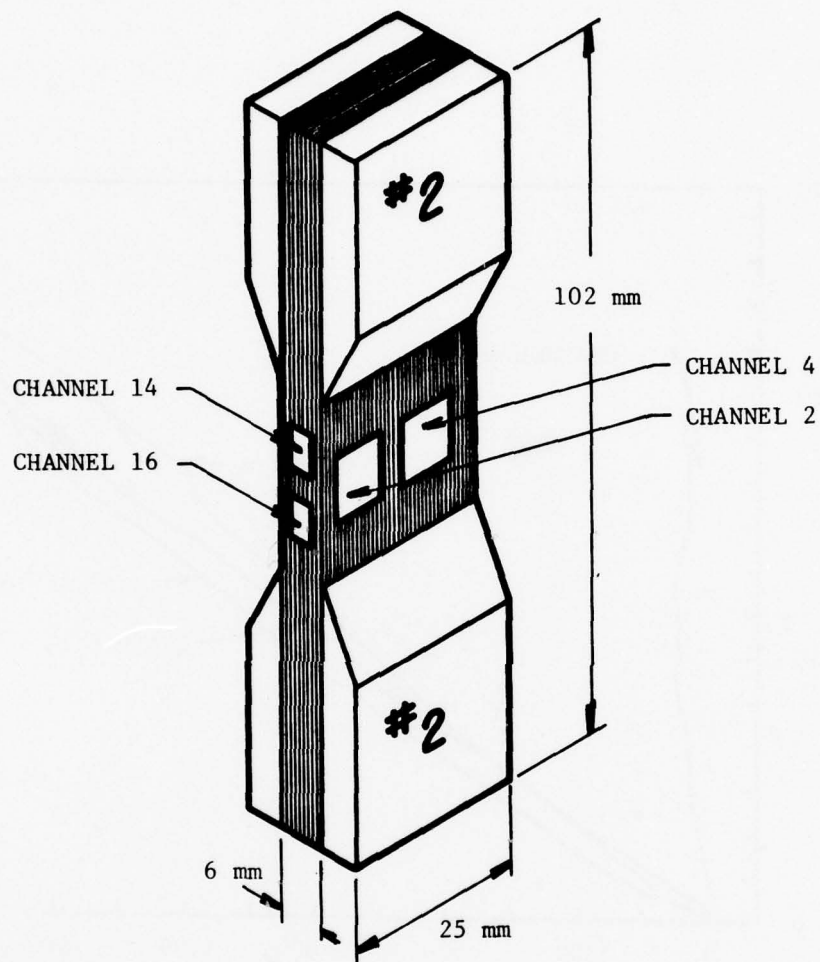
FIGURE 12. SKETCH OF TYPICAL TENSION SPECIMEN  
WITH BIAXIAL STRAIN GAGES ON EACH  
FACE.

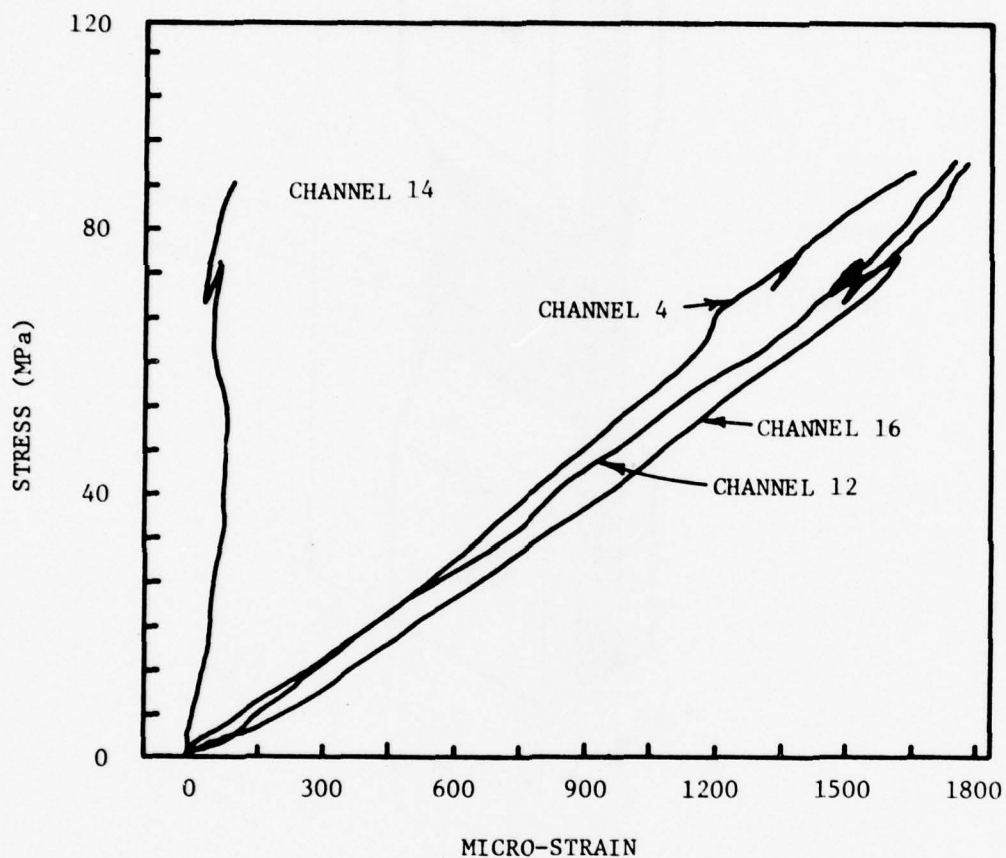
FIGURE 13. TYPICAL STRESS-STRAIN RELATIONS FOR THREE LONGITUDINAL STRAIN GAGES (THE FOURTH GAGE SHORTED OUT) ON A TENSILE SPECIMEN. A STRAIN READING FROM A TRANSVERSE GAGE IS SHOWN FOR COMPARISON (CHANNEL 14). SPECIMEN T-7 (Y-DIRECTION).

Figure 13 shows typical curves for three of the longitudinal gages (the fourth gage shorted out) on a specimen oriented in the y-direction. The agreement among all of the gages is considered excellent. As for the compression samples, a straight line was fit to the initial portion of the stress-strain curve. The data fit the straight line very well in nearly every case. Again, as was found in the compression tests, the

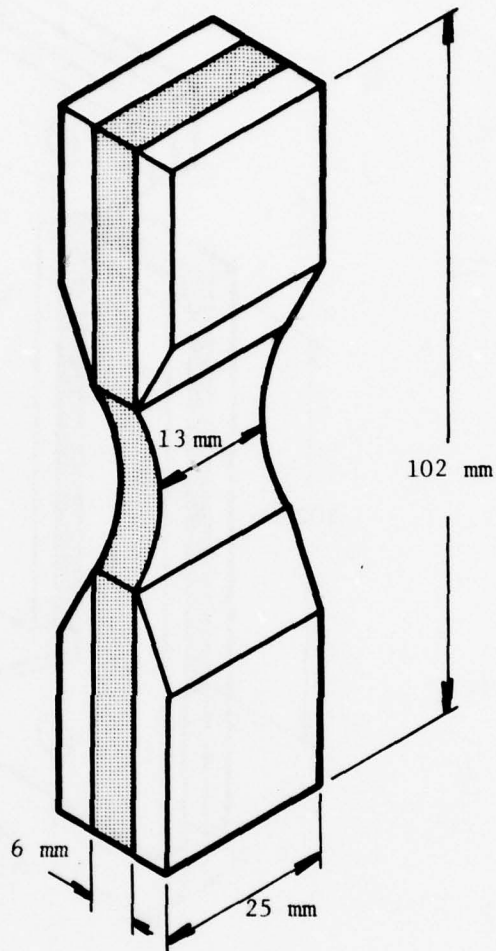
FIGURE 14. SKETCH OF TENSILE SPECIMEN WITH A REDUCED CROSS-SECTIONAL AREA IN THE CRITICAL TEST REGION.

The tensile specimens having the letter R in parentheses in Table 4 each had a reduced cross-section, as shown in Figure 14. This was done because in the original tests of specimens T-1, T-2 and T-3, the fibers were so strong that the specimens pulled out of the fiberglass tabs. In the subsequent tests of specimens T-2 and T-3, the specimens again sheared out of the tabs. It must therefore be assumed that the ultimate strengths for these specimens are not accurate, but that the calculations for the elastic modulus are representative, since the shear failures occurred in the nonlinear portions of the stress-strain curves.

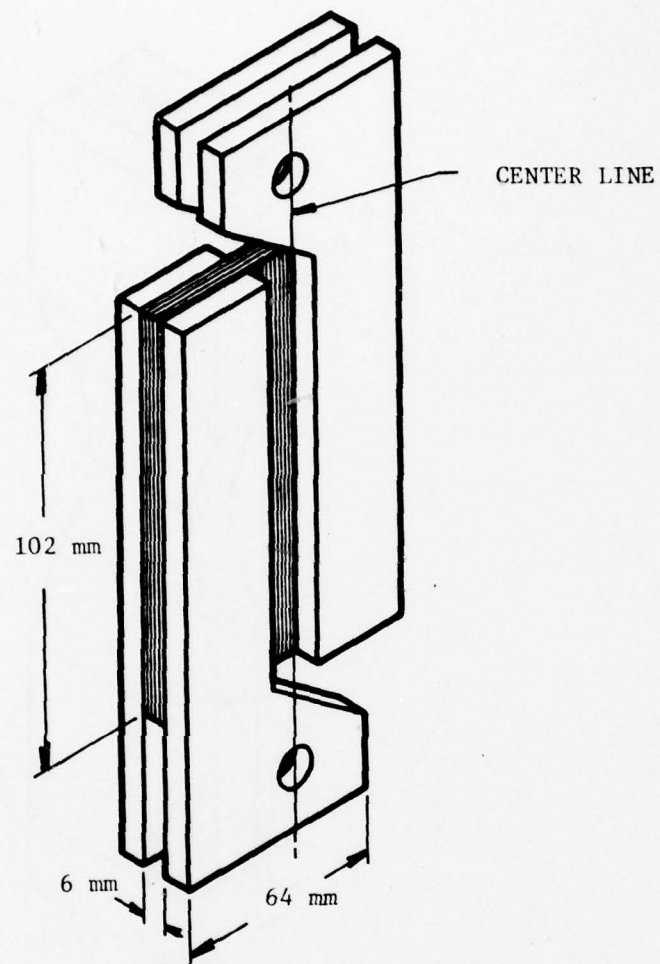
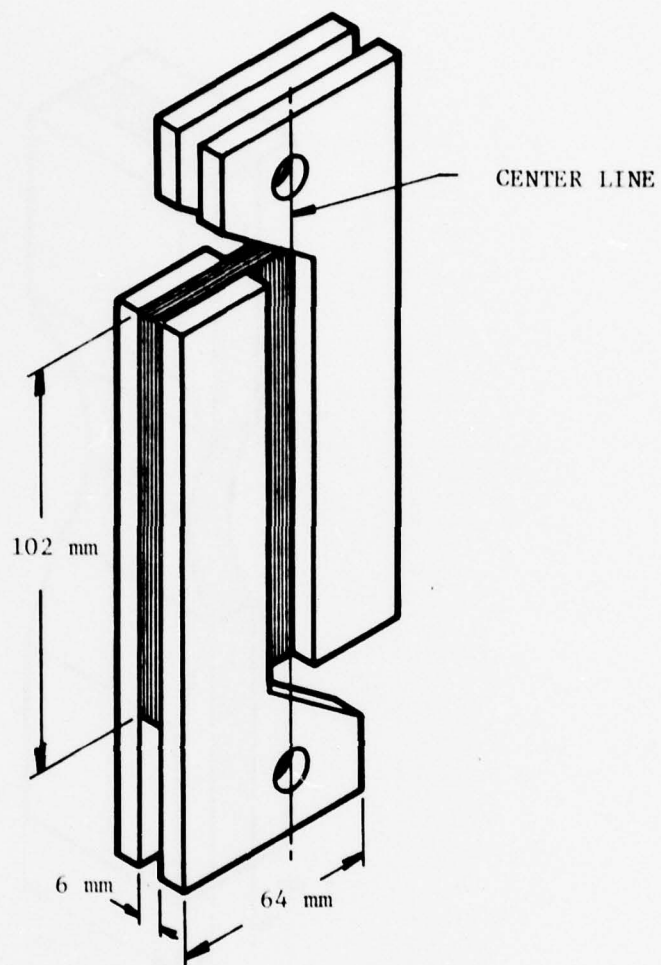
FIGURE 15. SCHEMATIC DRAWING OF RAIL SHEAR SPECIMEN.

Rail shear tests were conducted to produce shear loading along a plane parallel to the loading direction (Figure 15). Strain gages for the shear specimens were aligned parallel to the loading axis, perpendicular to the loading axis, and at 45°. Figure 16 shows a typical plot of all six strain readings. Channels 2 and 8 (noted on curves) are at 90° to the loading axis, channels 4 and 10 are parallel to the load axis, and channels 6 and 12 are at 45°. As can be seen, the deformation is highly nonlinear, and it is not possible to fit a straight line to any portion of these stress-strain curves. Thus, the only results tabulated are for the ultimate strength; these are given in Table 5. It is interesting to note that shear planes perpendicular to both the y- and the z-fiber directions failed at approximately the same stress levels. Apparently, the fiber strength has little effect on the shear strength of this material.

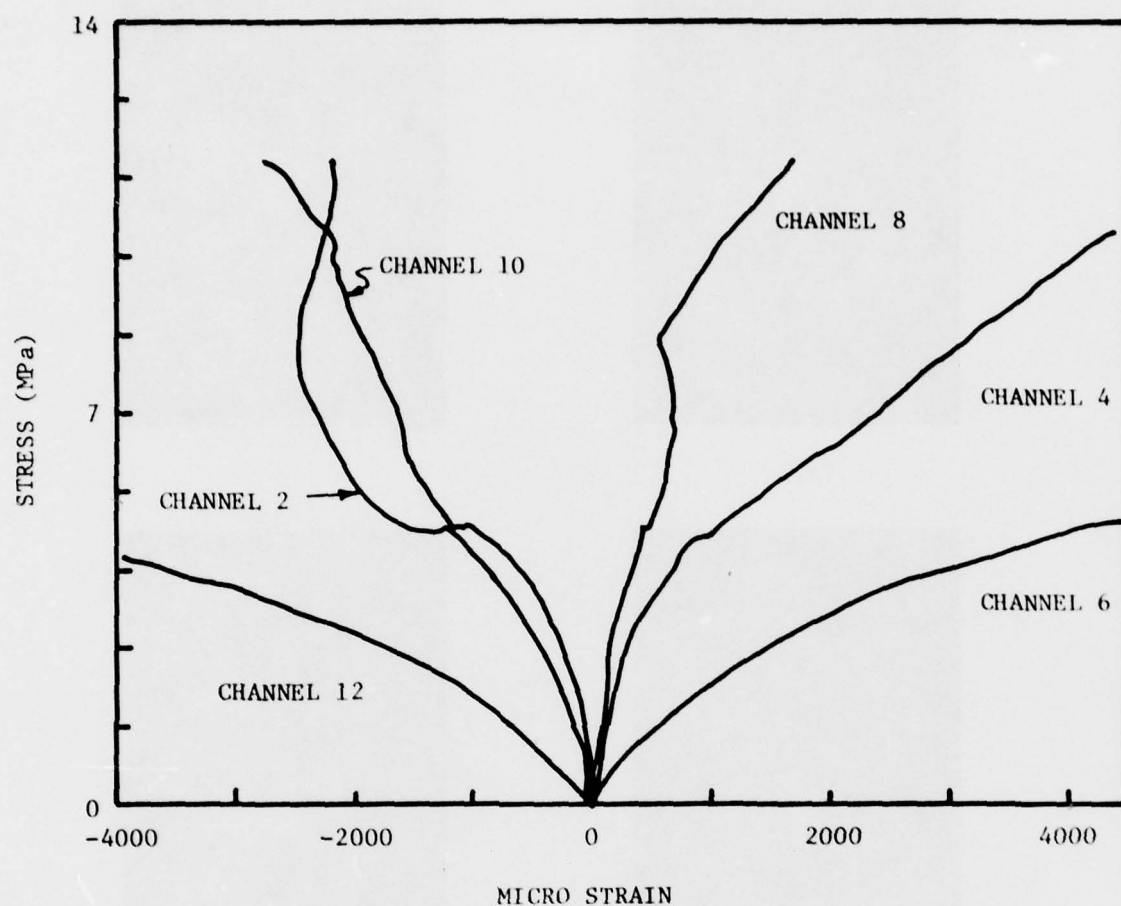
FIGURE 16. TYPICAL STRESS-STRAIN CURVES FOR RAIL SHEAR TESTS. SPECIMEN S-6 (Y-DIRECTION) CHANNELS 2 AND 8 ARE STRAINS PERPENDICULAR; CHANNELS 4 AND 10 ARE PARALLEL; AND CHANNELS 6 AND 12 ARE ORIENTED AT  $45^\circ$  TO THE LOADING DIRECTION.

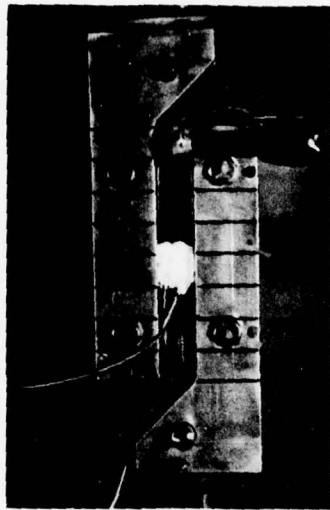
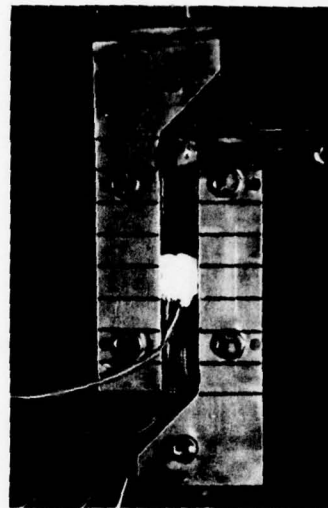
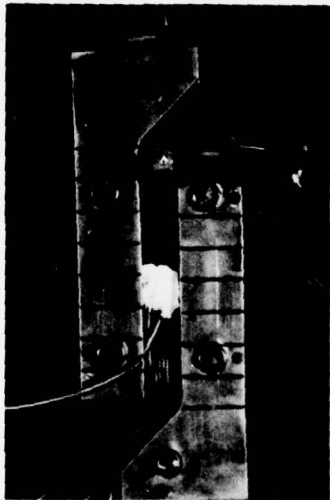
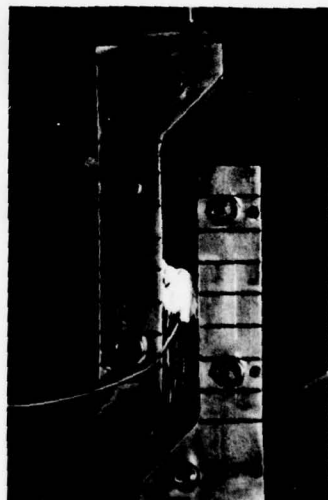
FIGURE 17. LOADING SEQUENCE DURING RAIL SHEAR TEST. SPECIMEN S-2: 00 MPa, 6.4 MPa (0.93 ksi), 14.4 MPa (2.09 ksi), 17.2 MPa (2.50 ksi). ACOUSTIC EMISSION TRANSDUCER IS ATTACHED TO THE TOP REGION OF THE SPECIMEN IN a, b and c.

The most remarkable phenomenon in the shear tests was the amount of deformation the material could sustain before fracturing. Figure 17 shows a loading sequence of specimen S-2, beginning at zero load and progressing to a maximum shear stress of approximately 2500 psi. At this point the inelastic deformation continued, but the load-carrying ability of the material began to decrease. As shown in Figure 18 the residual deformation in the specimen is substantial.

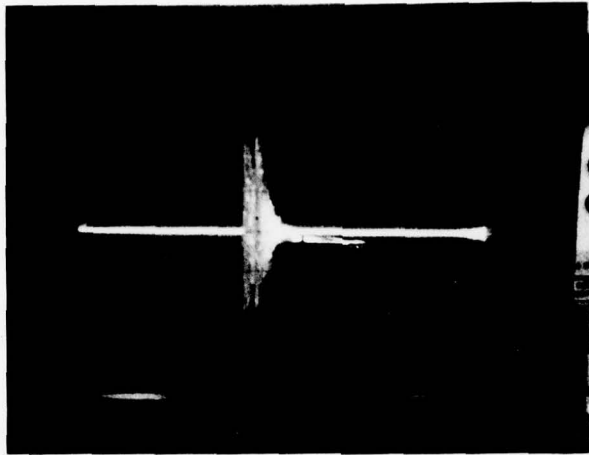
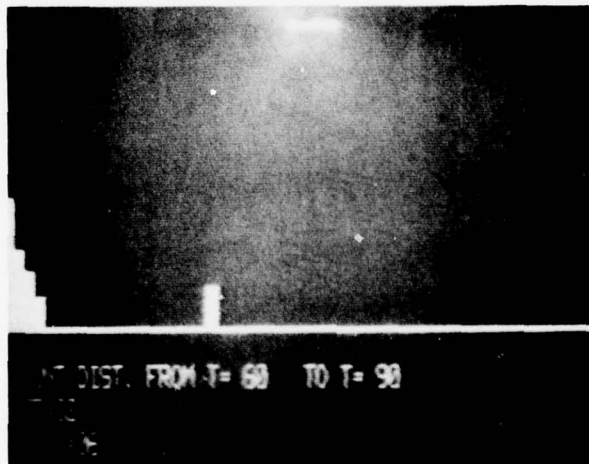
FIGURE 19. PENTEL 0.5mm LEAD BREAK ON SPECIMEN C-24:  
a) 0.2 VOLTS PER DIVISION - VERTICAL;  
1 MILLISECOND PER DIVISION - HORIZONTAL,  
150-400 KHz BANDPASS; 40 dB GAIN; b) COUNT  
DISTRIBUTION GRAPH; 60 dB GAIN.

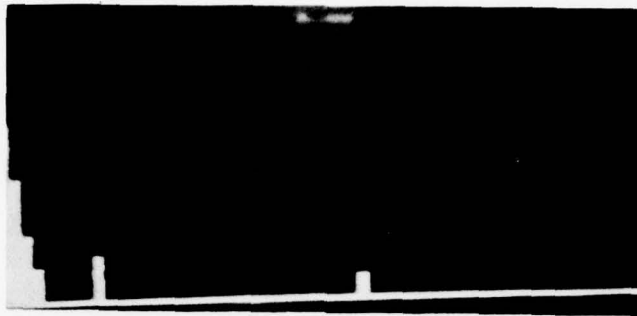
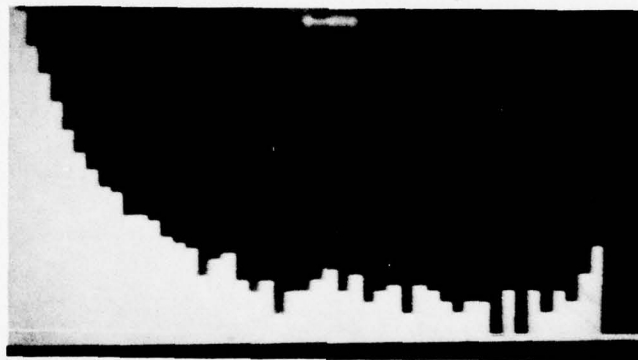
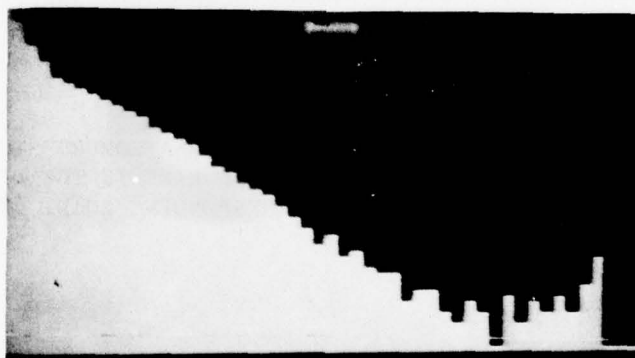
FIGURE 20. COUNT DISTRIBUTION GRAPH, SPECIMEN C-10;  
40 dB GAIN: a) 46 MPa (6.67 ksi);  
b) 75 MPa (10.8 ksi); c) END OF TEST.

Figure 21 shows a typical load vs longitudinal displacement plot for a compression test. There was a major drop in stress at, or perhaps just below, the maximum stress a specimen could sustain. This drop in stress was usually accompanied by a corresponding drop in strain, since the onset of damage usually occurred at the ends of the specimen where the load was applied. This drop coincided with the first large audible cracking noise and resulted in a cumulative AE count as shown in Figure 20a. Following this unloading phenomenon, the specimens again began to accept increasing loads. During this reloading period, significant additional low-level AE signals and a substantial number of intermediate-level signals were recorded. It was, in general, a very quiet period for acoustic noise in that little or no high-level AE signals were recorded. The stress level reached just prior to the first breakdown was usually just below the maximum stress attained in any given test. Upon the first reloading, the peak stress was attained and was immediately followed by a second loud audible crack. Once again, the audible crack coincided with a significant number of high-level acoustic signals (Figure 20b). In most cases the subsequent cycles of reloading did not reach peak stress, but declined steadily. At this point the specimen was considered to have failed. The subsequent cycles emitted much softer audible noise, and during these reloadings many more counts were recorded in the intermediate levels of the AE plot. By the end of the test the cumulative plot of all AE signals looked similar to Figure 20c.

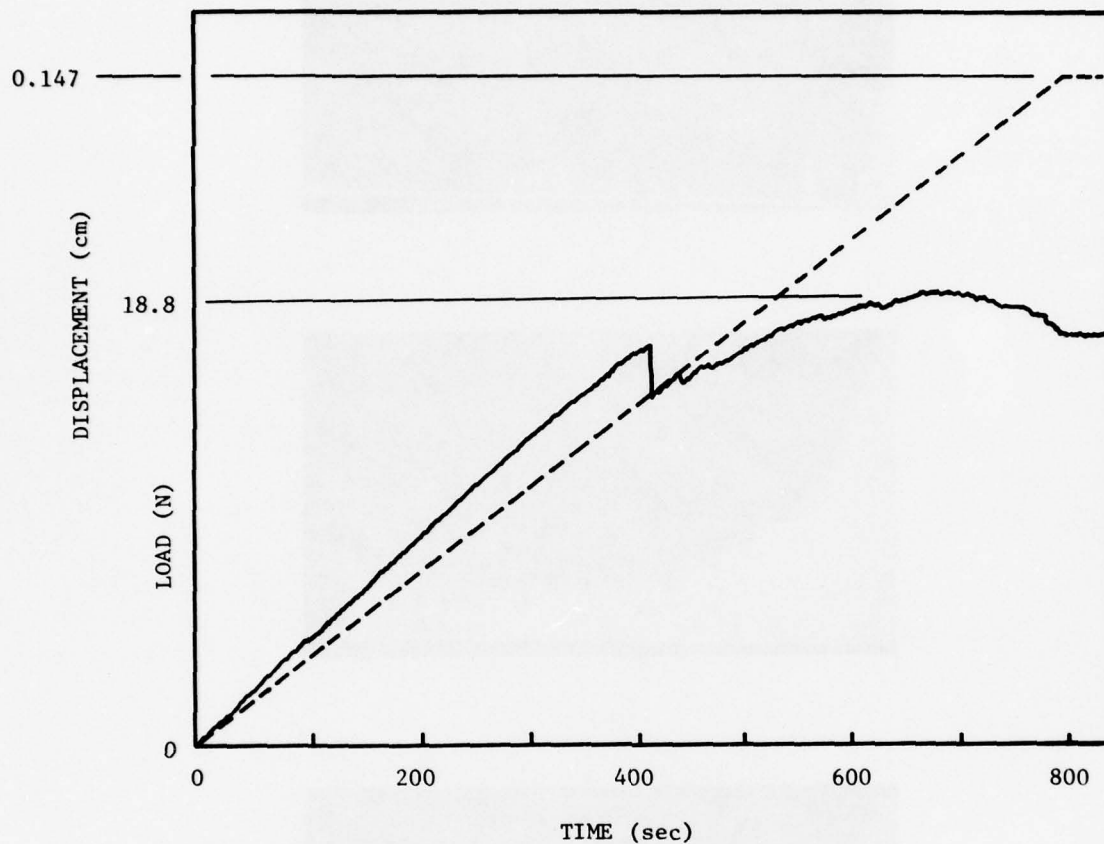
FIGURE 21. TYPICAL LOAD-DISPLACEMENT CURVE FOR A COMPRESSION TEST UNDER DISPLACEMENT CONTROL. THE BROKEN LINE IS THE DISPLACEMENT AND THE SOLID LINE IS THE CORRESPONDING LOAD. SPECIMEN C-19.

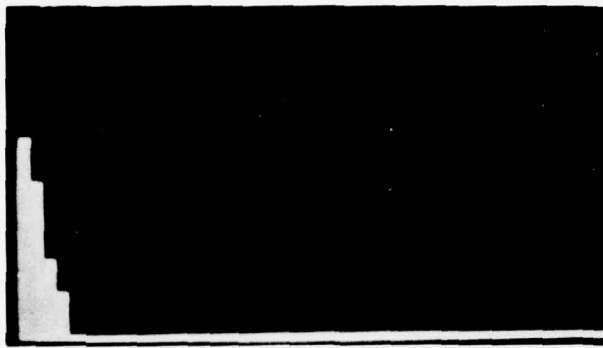
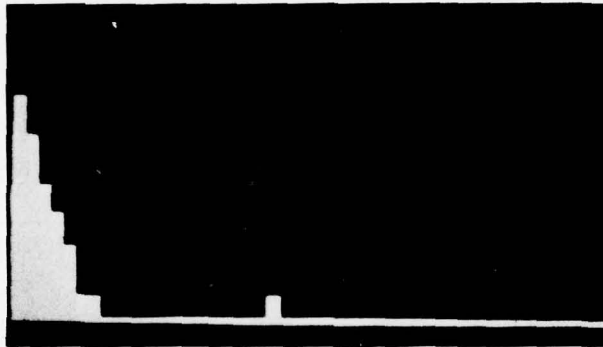
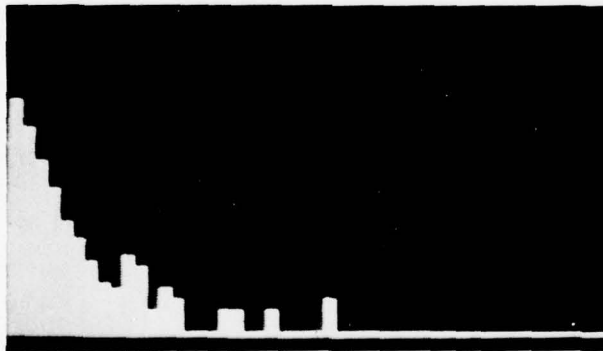
FIGURE 22. AE COUNT DISTRIBUTION GRAPH FOR SPECIMEN T-3. 40 dB GAIN: a) 53 MPa (7.8 ksi); b) 80 MPa (11.6 ksi); c) 138 MPa (19.4 ksi), END OF TEST.

The same acoustic emission monitoring process was used for most of the tension tests, and the results were very similar, as seen in Figure 22. Figure 22a shows the cumulative AE count at 134 MPa (19.4 ksi) stress. This was very early in the test, and the only signals were low-level noise. Figure 22b shows the cumulative AE spectrum after the first loud audible crack was heard. It is presumed that the counts at the single high amplitude were from fiber breakage. Finally, Figure 22c shows the AE accumulation at the end of the test. At the end of the tension test the low-level noise had filled in somewhat, and high-level signals had been recorded at several different amplitude ranges. In contrast to the AE accumulation at the end of the compression tests, low- and medium-amplitude signals were much less numerous in tension. This was probably due to the fact that the compression test had no definite failure point, and as the tests continued, the specimens began to crumble and spall at the ends.

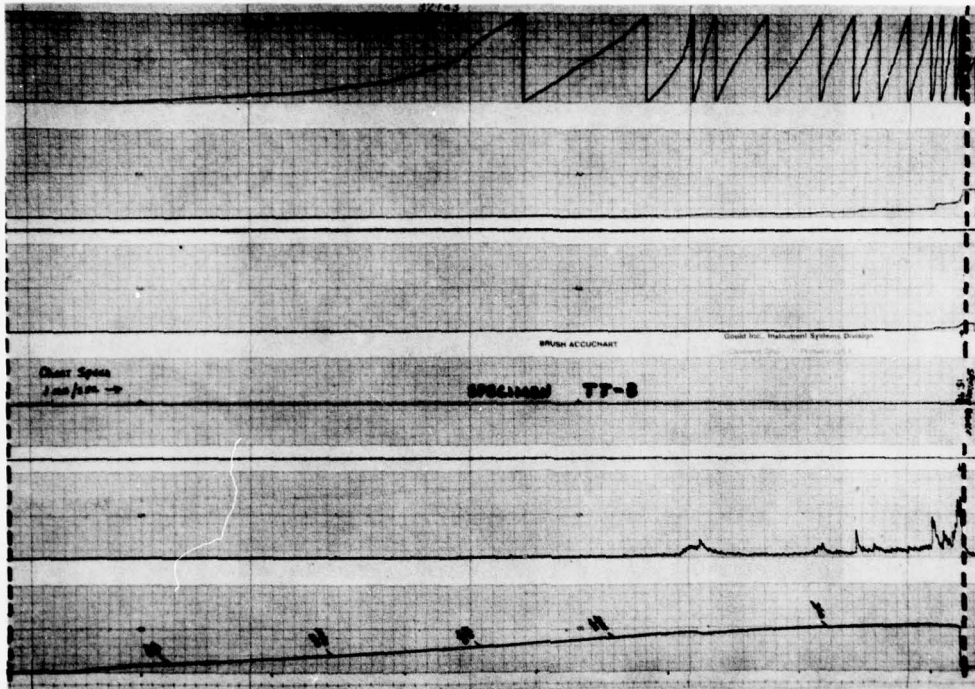
FIGURE 23. ACOUSTIC EMISSION DATA. BOTTOM CHANNEL IS LOAD, 5000 POUND, FULL-SCALE. SECOND CHANNEL IS COUNT RATE WITH 10 mV THRESHOLD; FULL SCALE IS 5V. CHANNELS 4-6 ARE ACCUMULATED RING-DOWN COUNTS WITH THRESHOLDS OF 400 mV, 100 mV AND 10 mV, RESPECTIVELY; FULL SCALE IS 65,536 COUNTS. (SPECIMEN TT-3)

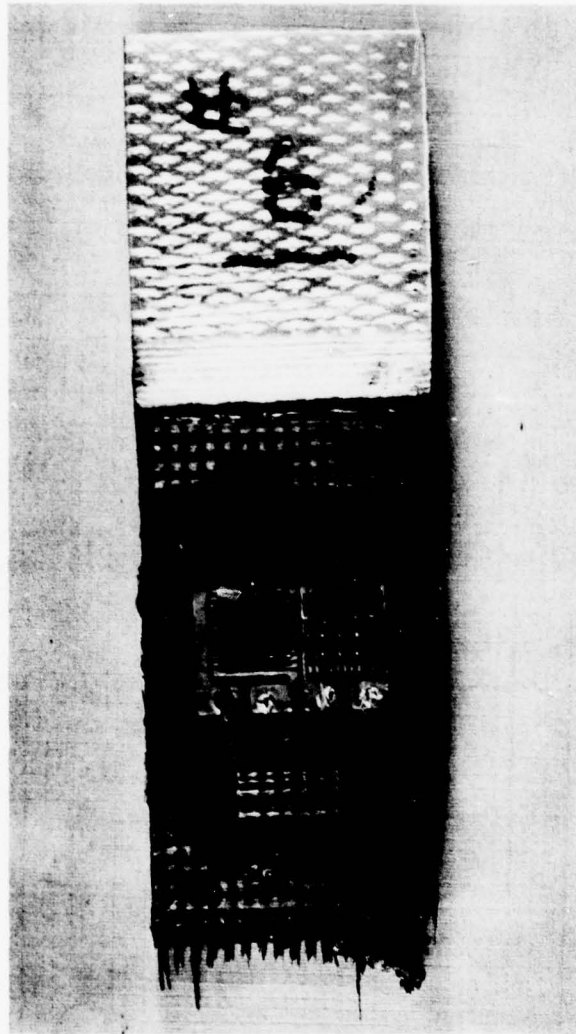
FIGURE 26. FAILED TENSILE SPECIMEN (SPECIMEN T-6) SHOWING VERY LOCALIZED FIBER FRACTURE. ORIENTATION OF THE SPECIMEN IS Y, Z, X (Y-BUNDLES ALONG THE LENGTH, TENSILE AXIS; Z-BUNDLES ACROSS THE WIDTH; AND X-FIBER BUNDLES THROUGH THE THICKNESS).

In analyzing the specimens after they had failed, it was noticed that the orientation of the strong fiber direction had significant influence on the mode of failure. Figure 26 shows the failure surface of specimen T-6. The thick fiber bundles are oriented across the width in this case, and the fiber bundles broke off straight across the specimen. There was very little, if any, apparent shear between the fibers and matrix regions. In contrast, specimen T-4 (Figure 27), in which the strong fiber direction is along the loading axis, showed a much greater tendency for the fibers to shear out of the matrix rather than fail in a tensile mode. There is presumably a great deal of shear deformation since the fiber bundles failed at different locations. If there were no shear deformation, the fiber bundles would all tend to fail along the same plane since a local failure of one bundle would cause a stress concentration and redistribution in the same region. However, the seemingly random locations of fiber bundle breakage indicates that substantial shear deformation may have distributed the stress concentrations along the test length. A direct indication of the shear during the tensile tests can be seen in the end of specimen T-4 (Figure 28). It is obvious that the longitudinal fiber bundles have pulled away from the transverse fiber bundles, even though all of the fibers failed within the test length of the specimen (refer back to Figure 27). Further examples of the shear deformations were seen in the tests of the thin tensile specimens (Figure 29). In many of these tests, in which the specimens were only two unit cells thick, some of the fiber bundles pulled completely out of the supporting structure without breaking.

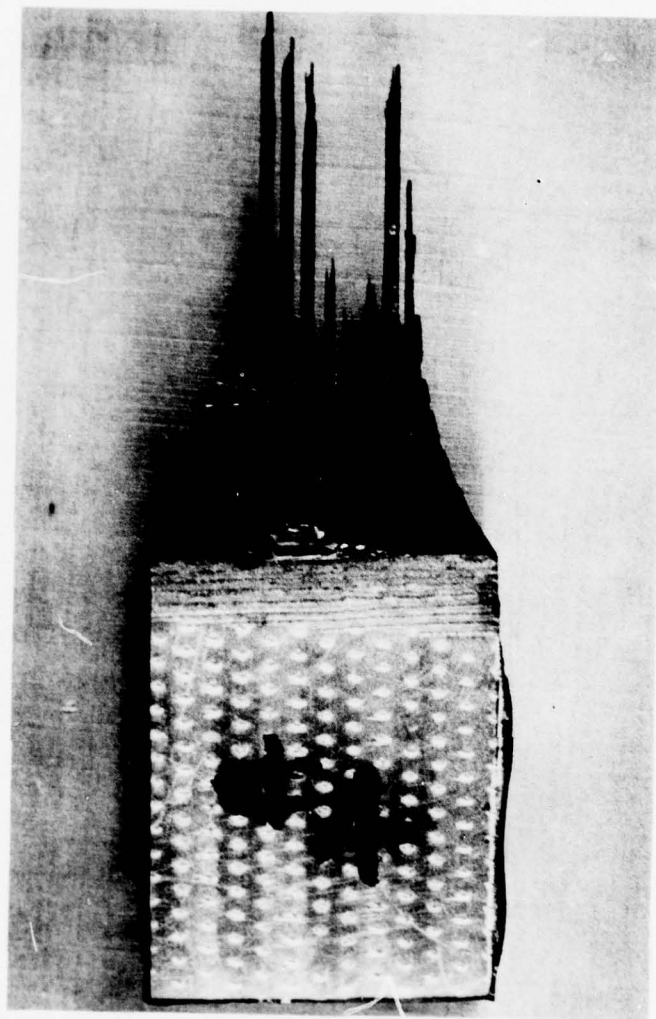
FIGURE 27. FAILED TENSILE SPECIMEN (T-4) SHOWING RANDOM FIBER FAILURE LOCATION. ORIENTATION OF SPECIMEN IS Z, Y, X.

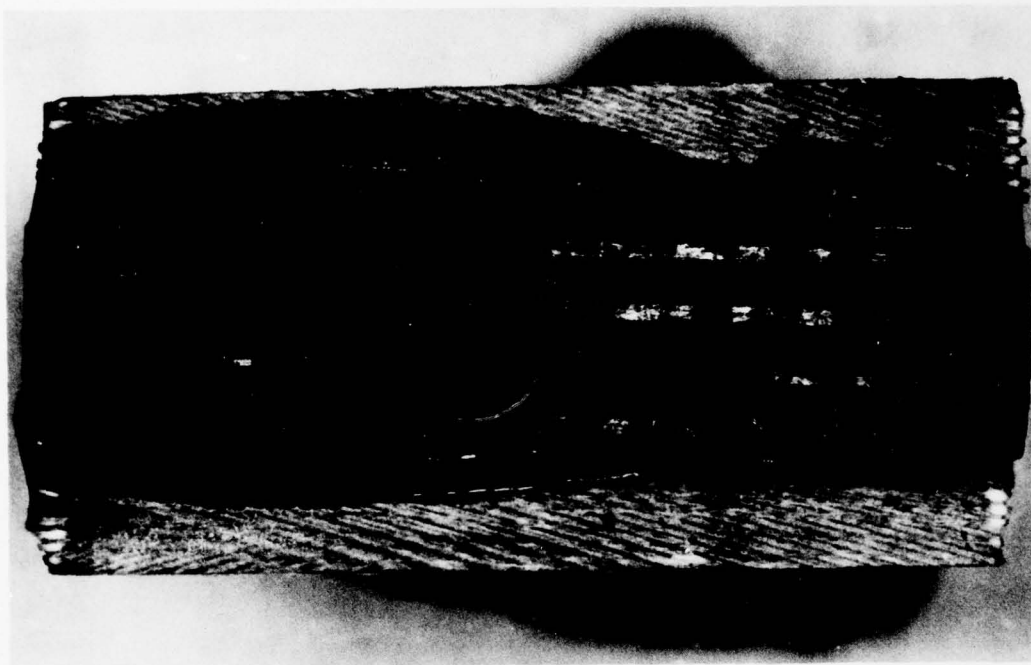
FIGURE 28. FAILED TENSILE SPECIMEN (SPECIMEN T-4) SHOWING LONGITUDINAL FIBERS WHICH HAVE PULLED OUT OF SURROUNDING MATRIX AND TRANSVERSE FIBER BUNDLE REGIONS, AT THE END OF THE SPECIMEN. SPECIMEN IS FOUR UNIT CELLS THICK.
